THE USE OF GIS DATA AND ANALYSIS IN THE DEVELOPMENT OF THE MOHAWK RIVER WATERSHED MANAGEMENT PLAN

Katie Budreski, Stone Environmental, Inc.

GIS NEEDS FOR WATERSHED PLANNING IN THE MOHAWK

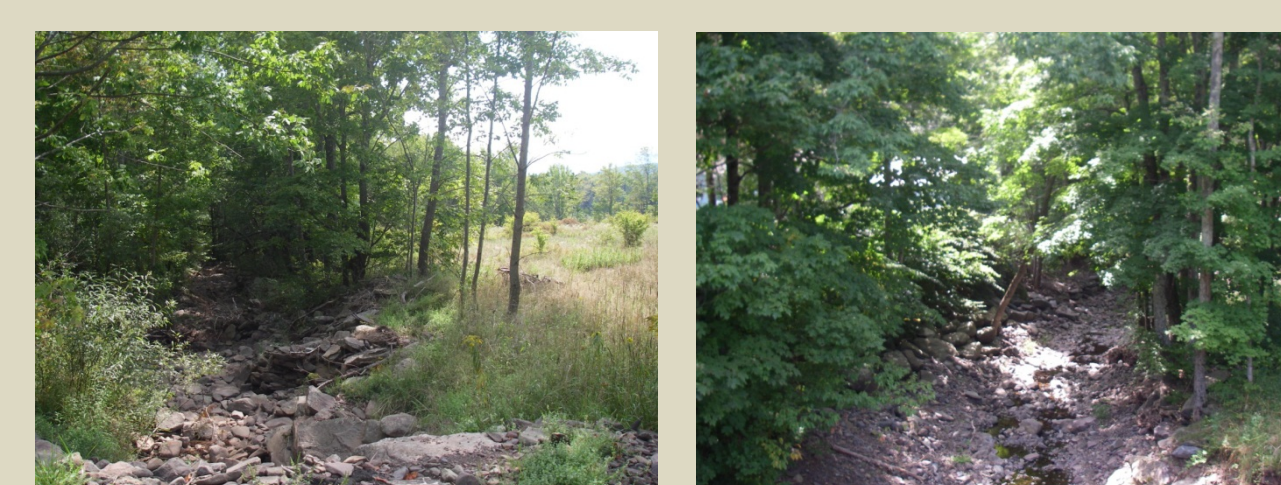
While the East Kill sub-watershed has excellent water quality, a portion of the East Kill watershed has cropland bordering streams (left). The majority of the East Kill watershed has forested riparian cover (right).

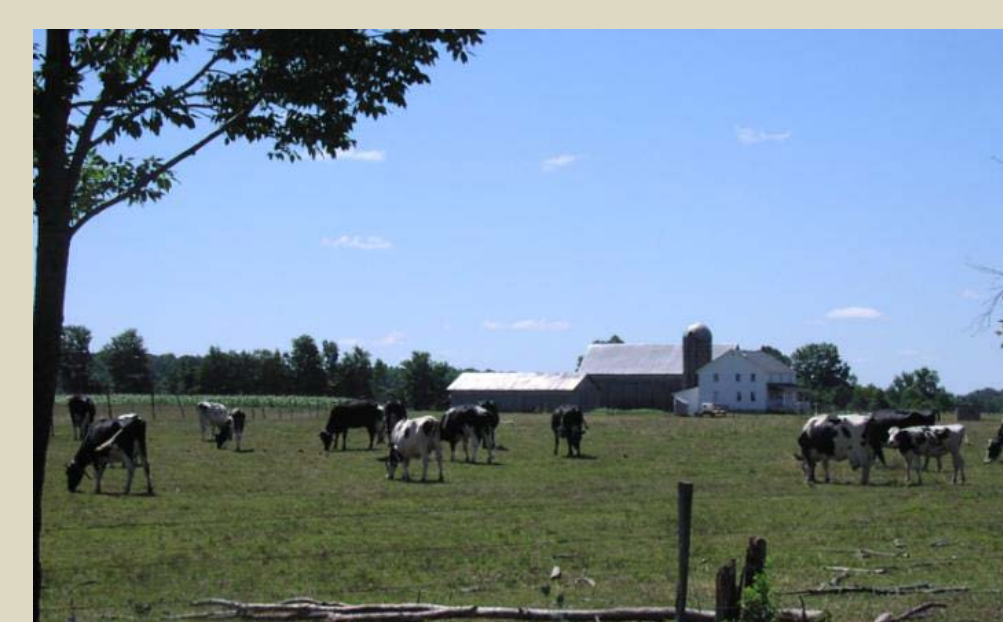
Higher numbers of livestock per acre is frequently a problem in the southern half of North Creek/Caroga Creek watershed, as seen here in this photo of a dairy farm on State Route 10.

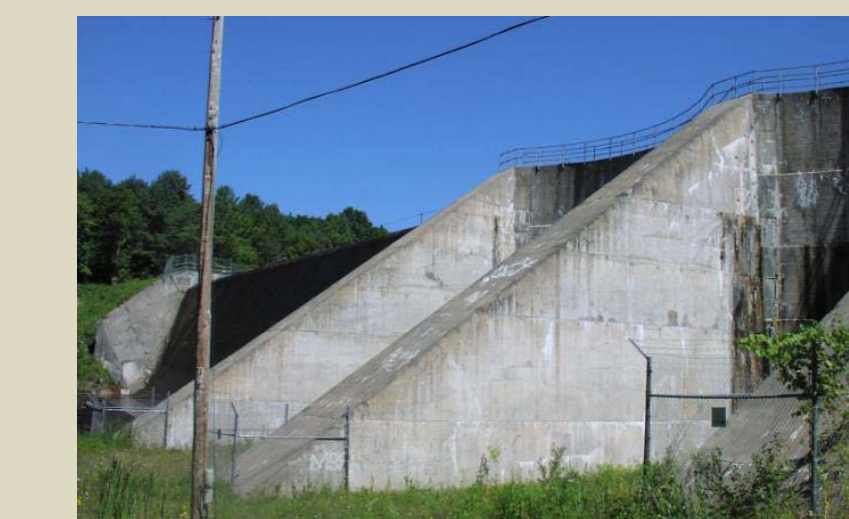
The hydroelectric power plant and dam in Ephratah causes fluctuations in the water flow of the lower Caroga Creek, resulting in minor impacts to habitat hydrology.
